# Manhole Inspection Summary

Manhole # S25CC\_032MH

**Location** Address: **1114 RIGGS AVE**

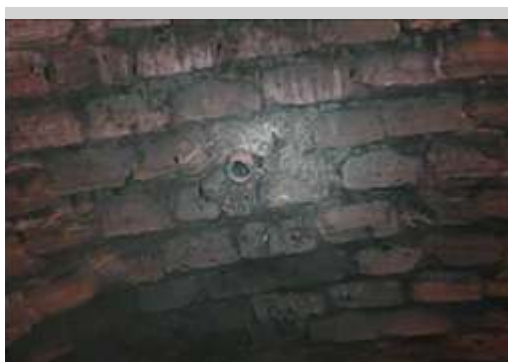
UNKNOWN CONNECTION INTO  
SEWER AT 6 OCLOCK.

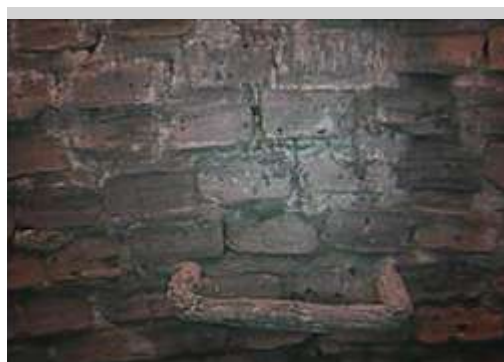
Defect 2

**Steps** Count: **3** Missing: **0** ☒ **Corroded**

CORRODED STEP

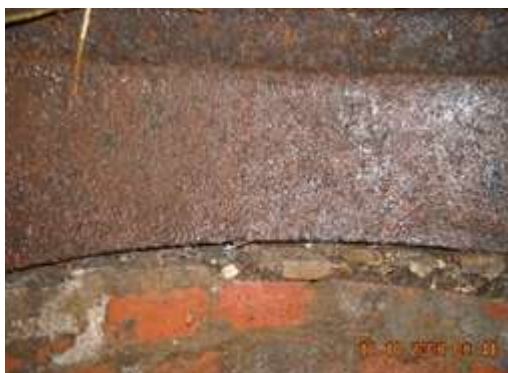
Defect 4

Condition: ☐ Sound ☐ Cracked ☐ Root Intrusion ☒ **Loose Brick** ☐ Deteriorated

MISSING BRICKS BELOW THE FRAME.

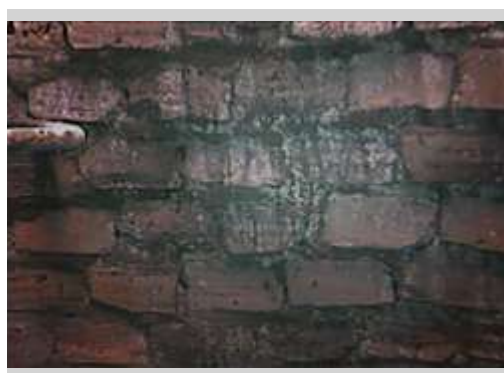
Defect 1

Infiltration: ☐ None ☒ **Joint** ☐ Cracks ☐ Mortar ☐ Roots ☐ Wall

INFILTRATION DUE TO GAP BETWEEN  
FRAME AND CHIMNEY.

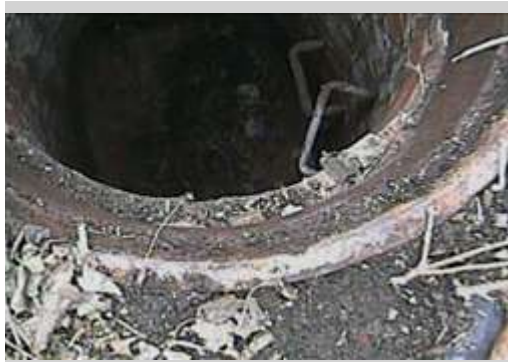
### Defect 3

**Frame** Offset: **2** (in.) Condition: ☐ Sound ☐ Cracked ☒ **Leaks**

FRAME IS OFFSET FROM CHIMNEY BY 2 INCHES.
